MARTECH

Issue Date Autumn 2008

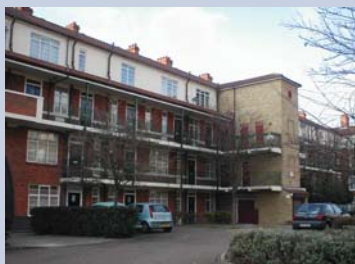
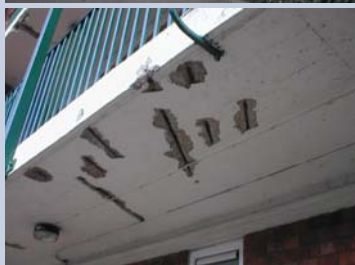
Martech have completed a concrete condition survey for a Housing Association on two blocks of flats in the Rotherhithe area of South London to ascertain the nature and extent of the reinforcement corrosion problems present there.

It was found by **Martech** testing engineers that the concrete suffers from cracking and spalling

as a result of reinforcement corrosion triggered by low cover and concrete carbonation – a naturally occurring process of concrete ageing where carbon dioxide from the atmosphere carbonates the alkaline cover concrete lowering the ph to levels where the embedded steel can corrode with the presence of moisture.

Martech recommendations for repair were submitted to the client with the detailed survey report allowing them to manage their budgets and plan for the necessary refurbishment programmes more efficiently.

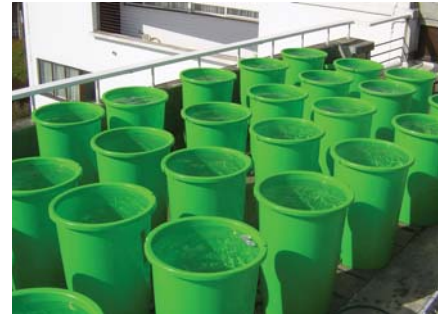
The clients structural engineers, Conisbee, instructed **Martech** staff on the installation of a number of plastic water tanks that were interconnected and filled to give a test load of 2.1 kN/m² or 215 litres per m² of water.

On the underside of the roof slab **Martech** erected a tower in a selected area and with the installation of four micrometer dial gauges with a measuring range of 0 – 10mm in 0.01mm increments deflection could be accurately measured.

Readings were taken by **Martech** from the start and at regular intervals until the water tanks achieved the full test load. Interestingly there was very little deflection during the loading and at the full test load the maximum deflection measured was 0.49mm.

The test required the load to remain in place overnight and for the tanks to be emptied slowly again taking regular measurements as the deflection relaxed under the reducing weight.

These results together with a full report of the load test were submitted to the structural engineers for them to complete their new roof design.

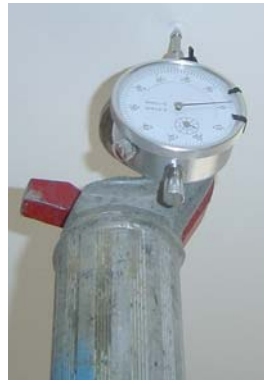
A grammar school science block constructed using a steel frame of RSJ's encased in concrete was investigated for the possible addition of a new top storey to be built on the existing flat roof.

Martech were commissioned to carry out a survey for the structural engineers to confirm the construction details of the steel frame and report on the condition of the existing concrete.

Martech testing engineers confirmed the main beams and columns to be of concrete encased RSJ's with the secondary beams of reinforced concrete and the roof slab of beam and pot construction. The condition of the existing concrete showed signs of advancing carbonation and together with low cover in places was causing localised steel corrosion and hence some cracking.

A detailed report by **Martech** confirmed the method of original construction and explained the cause and extent of the concrete problem to the client with included repair options.

Repair recommendations in this case were straight forward with traditional repairs to the spalled areas and the use of embedded corrosion inhibitors to treat the concrete encased steel frame members.

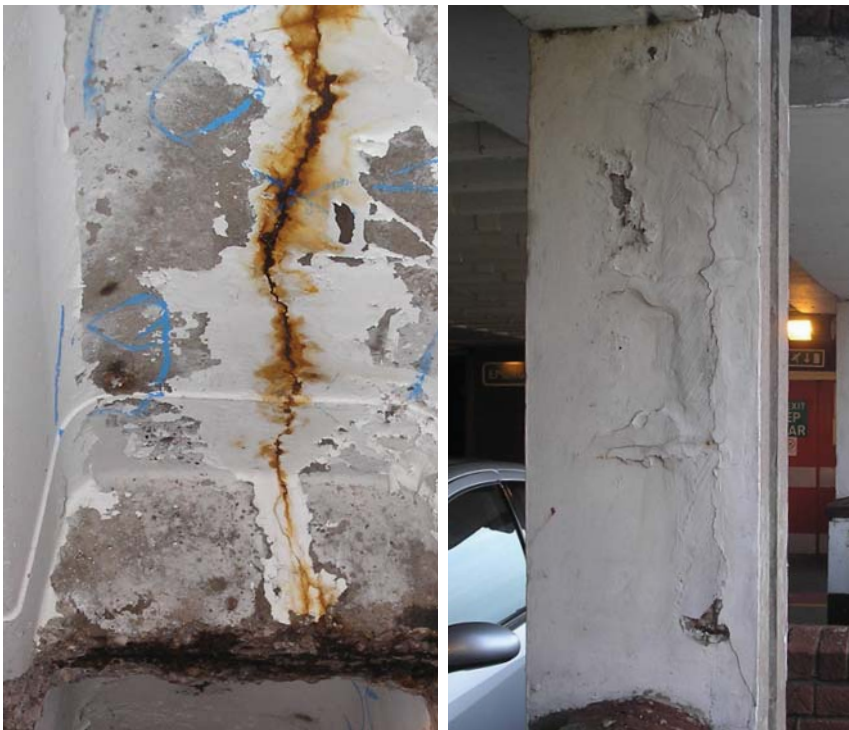
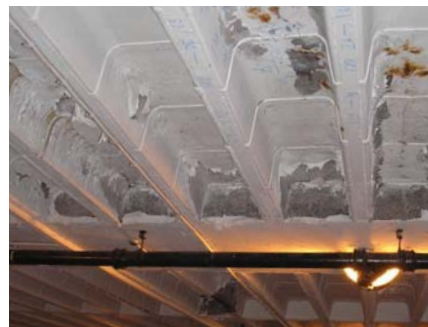
The effects of chlorides in concrete are exacerbated by advancing carbonation and low concrete cover, symptoms found on this MSCP in the Midlands by **Martech** testing staff. Following an extensive concrete condition survey, **Martech** submitted a detailed report together with repair solutions.

In this case the repair recommendations called for the use of electrochemical methods of corrosion control based on impressed current cathodic protection for the running decks and traditional repairs elsewhere.

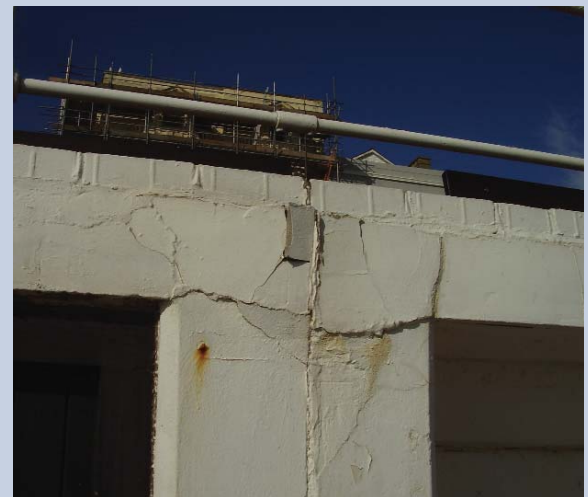
The work commissioned by the local authority is part of their coastal structures risk management strategy and involved **Martech** staff hammer testing and removing loose or spalling concrete followed by treating the exposed steel reinforcement and adjacent concrete areas with a protective coating.

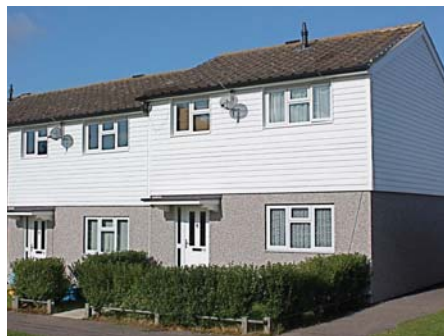
Martech are approved Surveyors and Installers of **Margel** Vapour Phased Inhibitors for use in reinforced or structural steel frame encased concrete.

A recent project involved **Martech** installing **Margel** 580 pellets into a number of non-traditional PRC (pre-cast reinforced concrete) homes as part of an overall refurbishment and upgrading programme.

The two storey homes are of exposed aggregate large panel design built in the 1950's and the **Margel** treatment is part of the Adams Specification Licence, a repair system developed by Adams Consulting Engineers that brings these buildings up to modern Decent Homes high standards of comfort, energy efficiency and low maintenance.

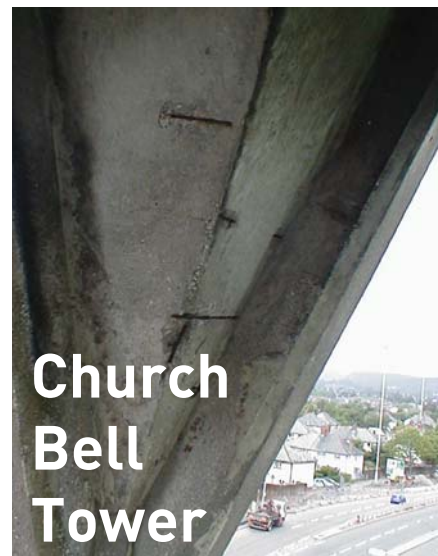
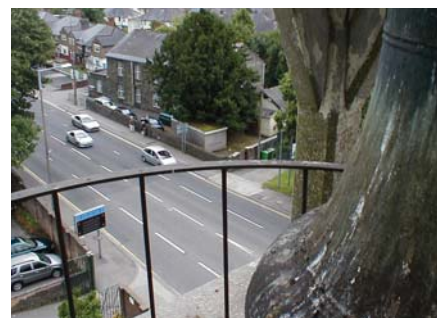
A reinforced concrete bell tower to a church in South Wales was suffering from spalling concrete to its structure.

The survey by **Martech** testing engineers found the concrete to have a combination of localised low cover to the steel reinforcement and advancing carbonation. There was also the presence of low to moderate chloride levels in some areas.

Martech recommended repair advice was to phase the works with the high level elements having priority. The repair techniques involved traditional concrete repair with selected use of corrosion inhibitors and overall protective coatings.
